Report of Dam Safety Assessment of Coal  
Combustion Surface Impoundments  
Hoosier Energy  
Frank E. Ratts Generating Station  
Petersburg, IN

AMEC Project No. 3-2106-0177.0005

September 2010

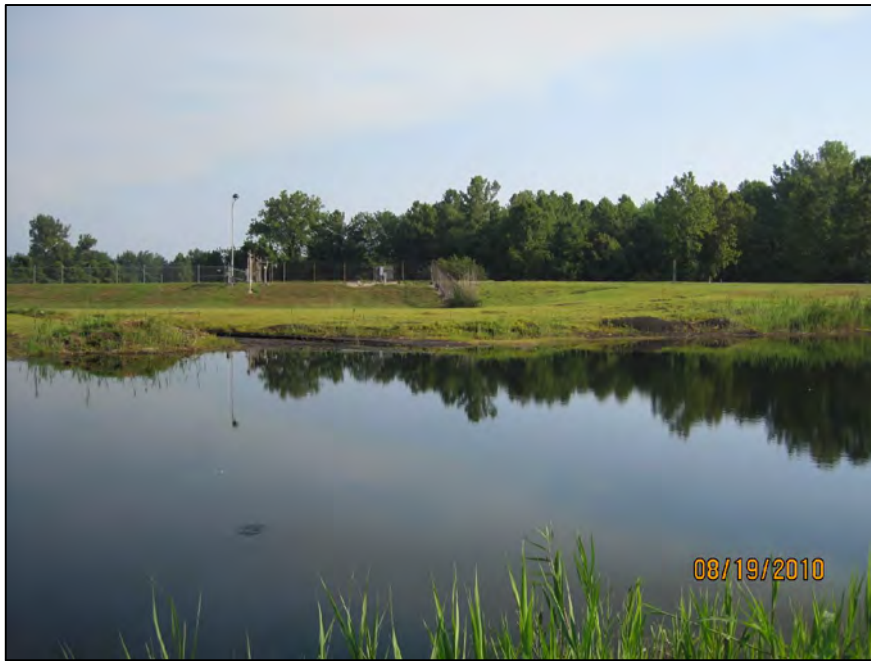
**1-1**

**VIEW FROM WITHIN POND 1 LOOKING TOWARDS EAST DIKE**

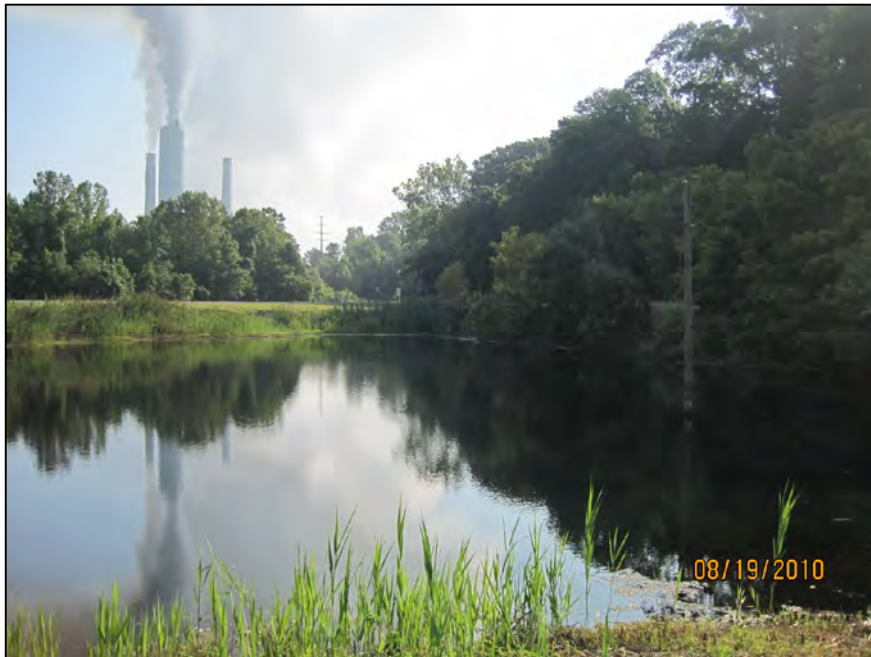
**1-2**

**VIEW FROM WITHIN POND 1 LOOKING SOUTHEAST CORNER OF POND**

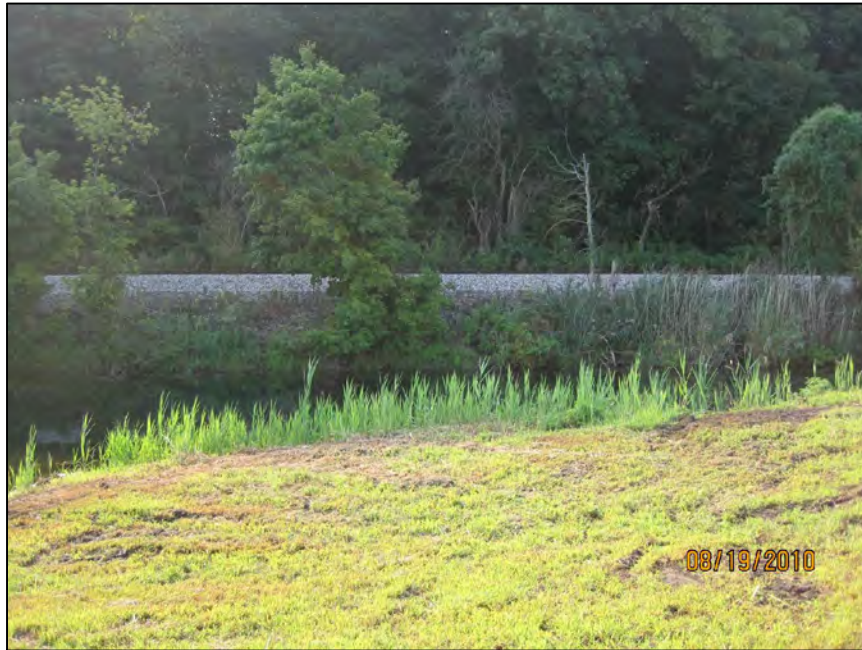
**1-3**

**VIEW FROM WITHIN POND 1 LOOKING SOUTH TOWARDS SOUTHERN EMBANKMENT**

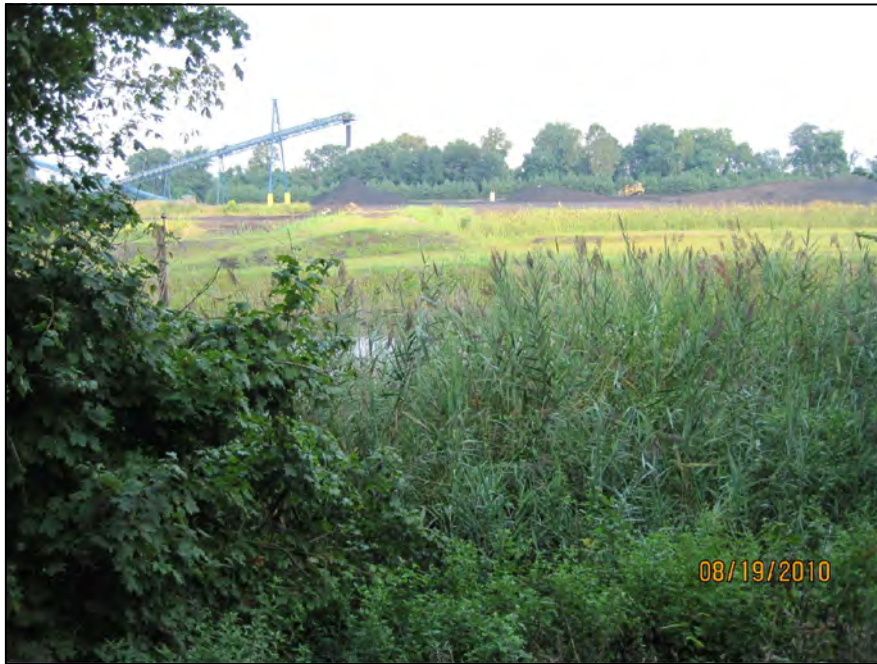
**1-7**

**VIEW FROM SOUTHERN DIKE LOOKING NORTH TOWARDS COAL PILE, NOTE VEGETATION**

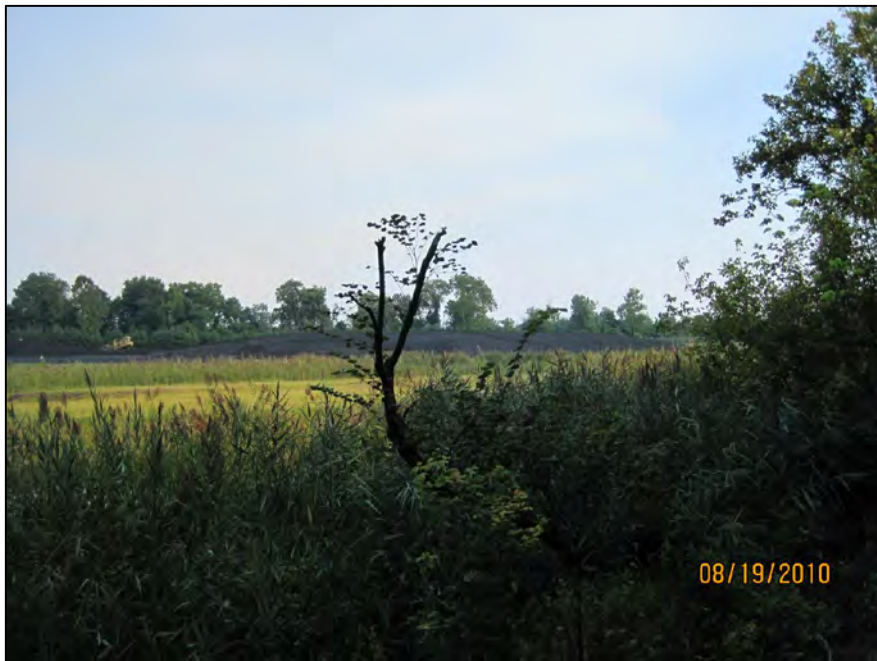
**1-8**

**VIEW FROM SOUTHERN DIKE LOOKING NORTH TOWARDS COAL PILE, NOTE VEGETATION**

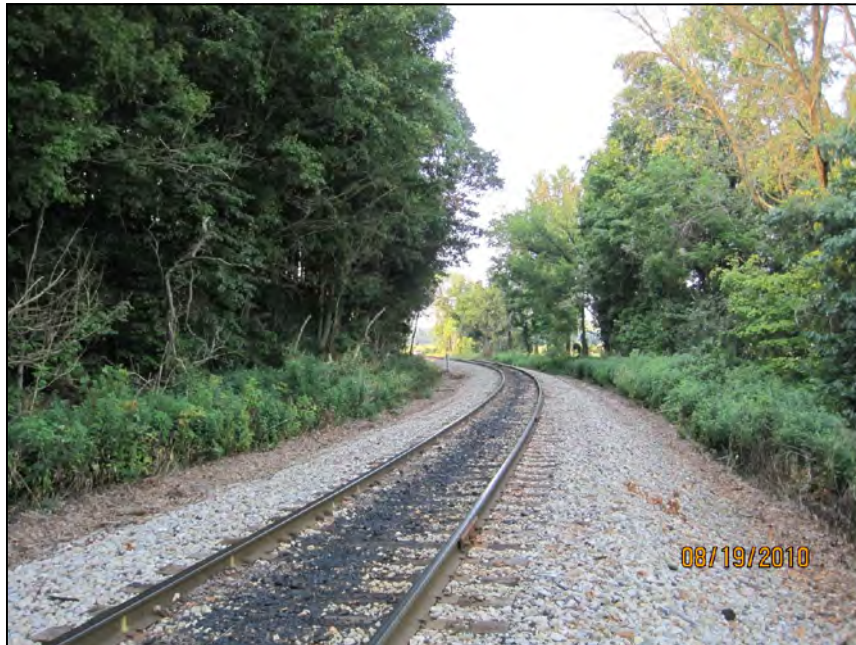
**1-9**

**VIEW FROM SOUTHERN DIKE LOOKING SOUTHWEST. EMBANKMENT ON RIGHT HAND SIDE, NOTE VEGETATION**

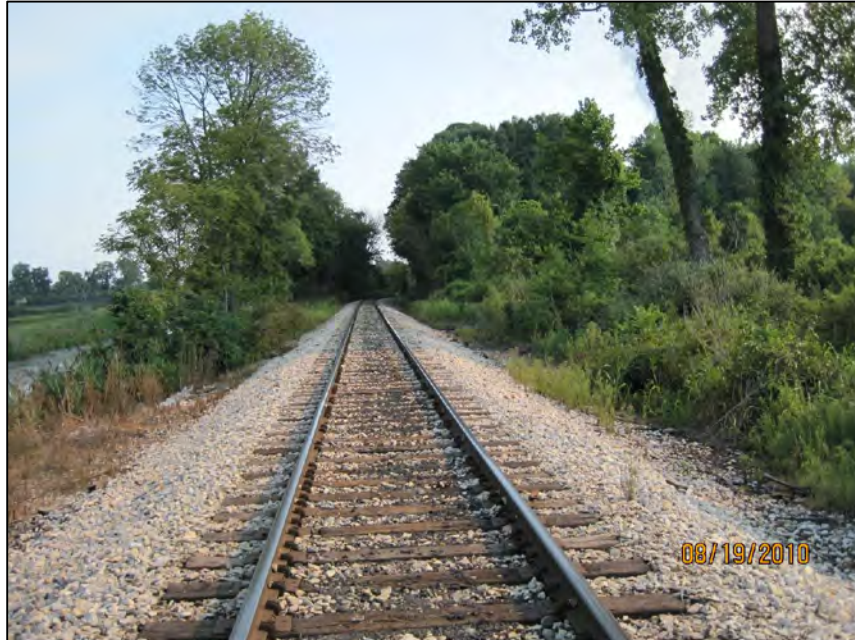
**1-11**

**LOOKING EAST ALONG SOUTHERN CREST, POND LOCATED ON LEFT-HAND SIDE**

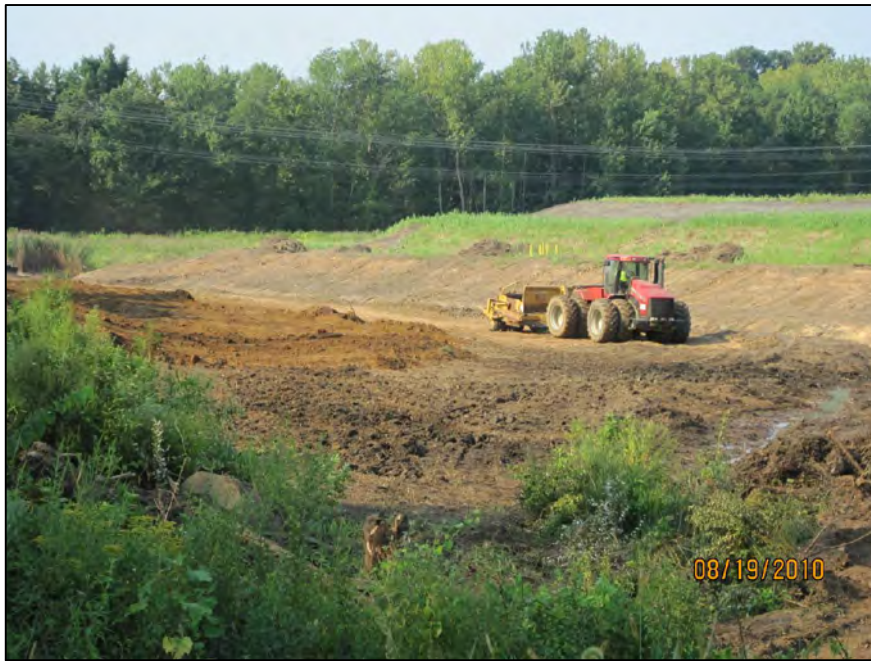
**3-1**

**CONSTRUCTION ALONG POND 3 SOUTHEASTERN DOWNSTREAM SLOPE**

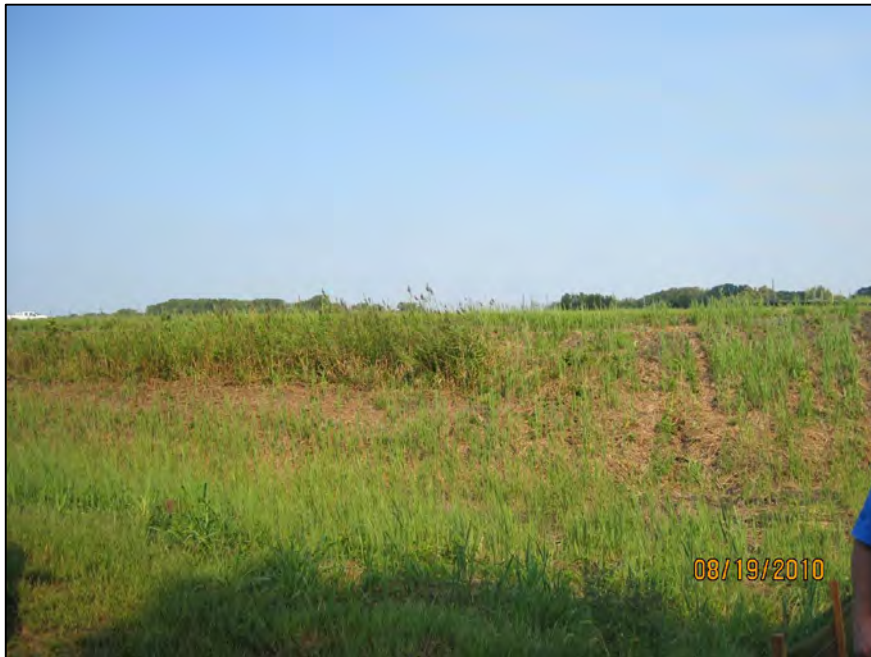
**3-2**

**SOUTHEASTERN DOWNSTREAM SLOPE**

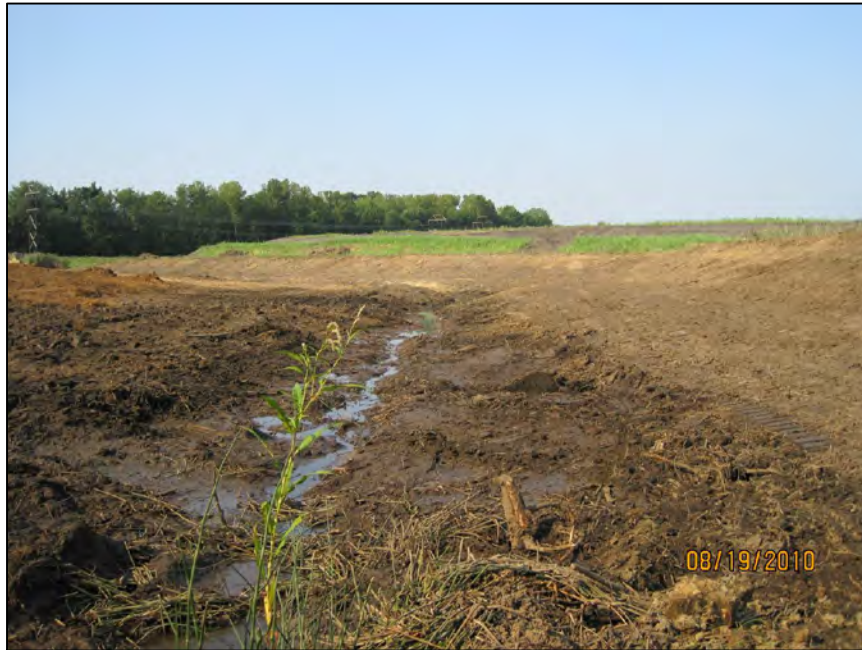
**3-3**

**DRAINAGE DITCH ALONG EASTERN DOWNSTREAM TOET**

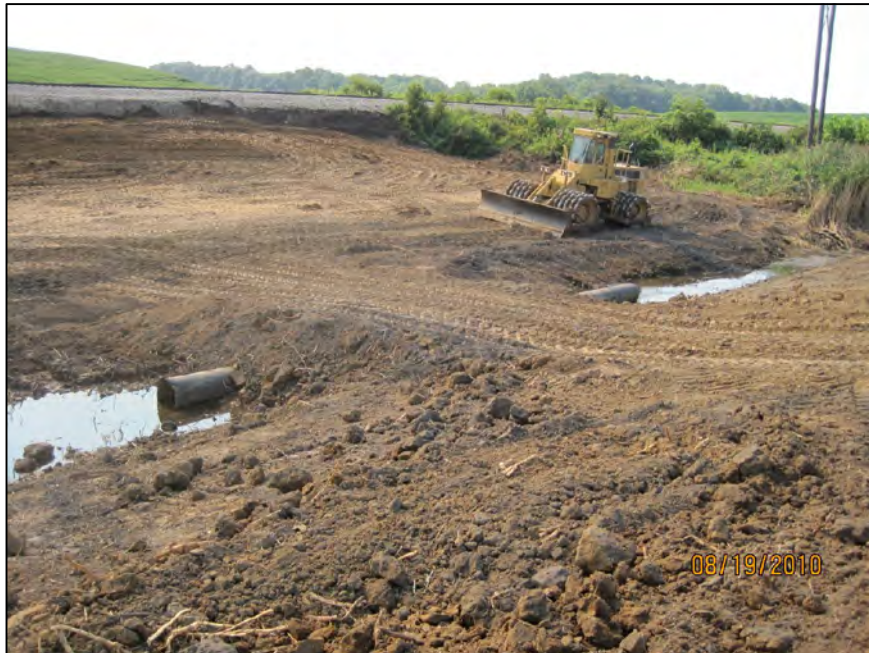
**3-6**  
**CONSTRUCTION ALONG POND 3 SOUTHEASTERN DOWNSTREAM SLOPE**

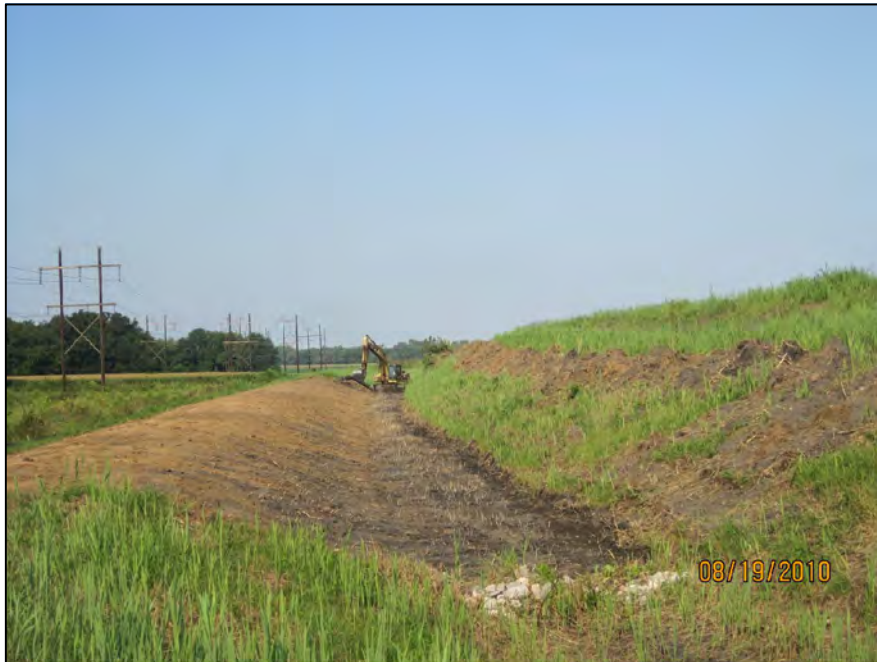
**3-7**

**FROM SOUTHEAST CORNER OF POND 3 LOOKING WEST AT DRAINAGE DITCH BETWEEN  
POND 3 AND OUTER DIKE**

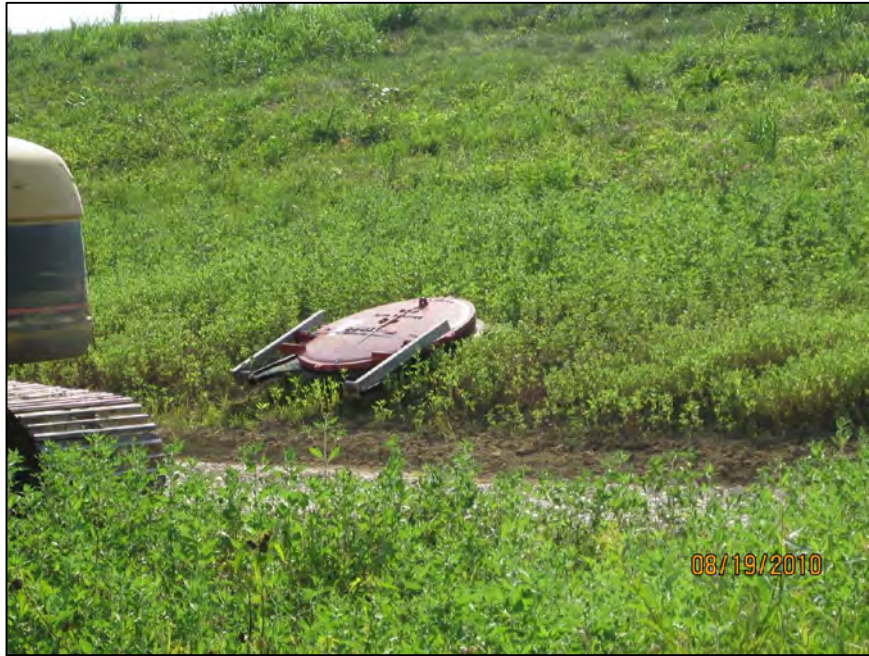
**4-5**

**NEW FLAP GATE FOR OUTFALL 003**

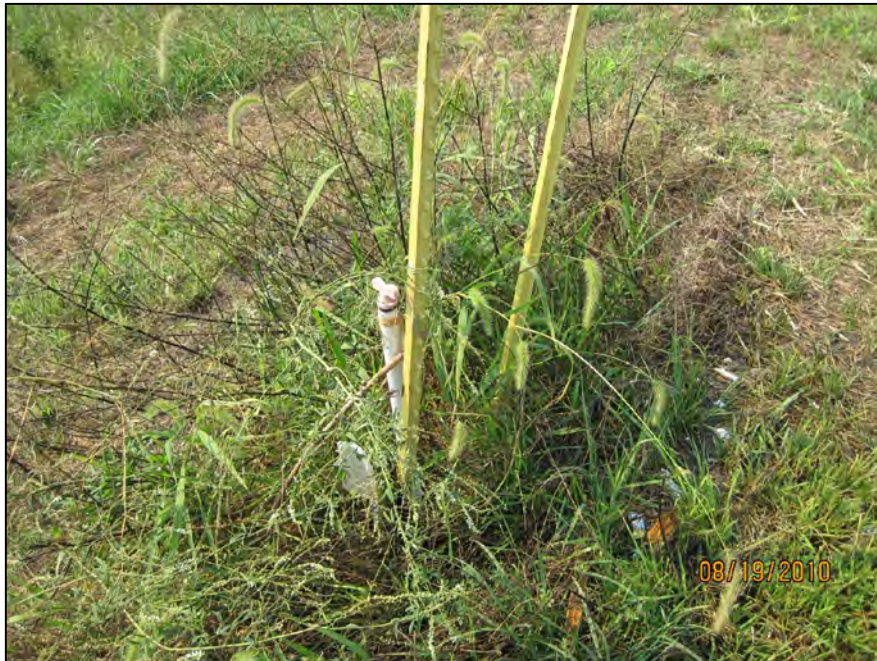
**4-8**

**PIEZOMETER LOCATED ALONG SOUTHERN DIKE OF SETTLING POND/NORTHERN DIKE OF POND 4**

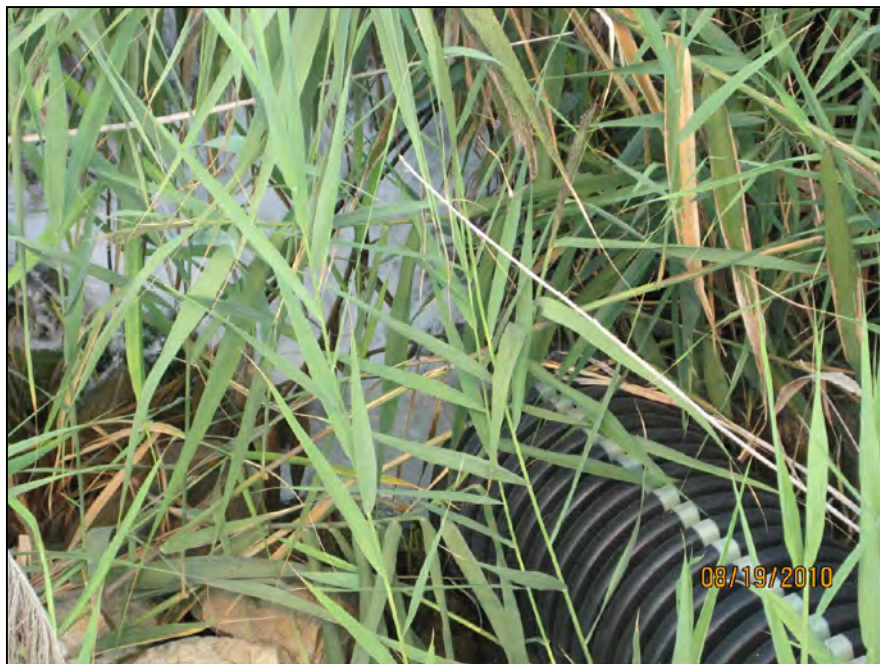
**4-14**

**OUTLET FROM POND 4 TO DRAINAGE DITCH**

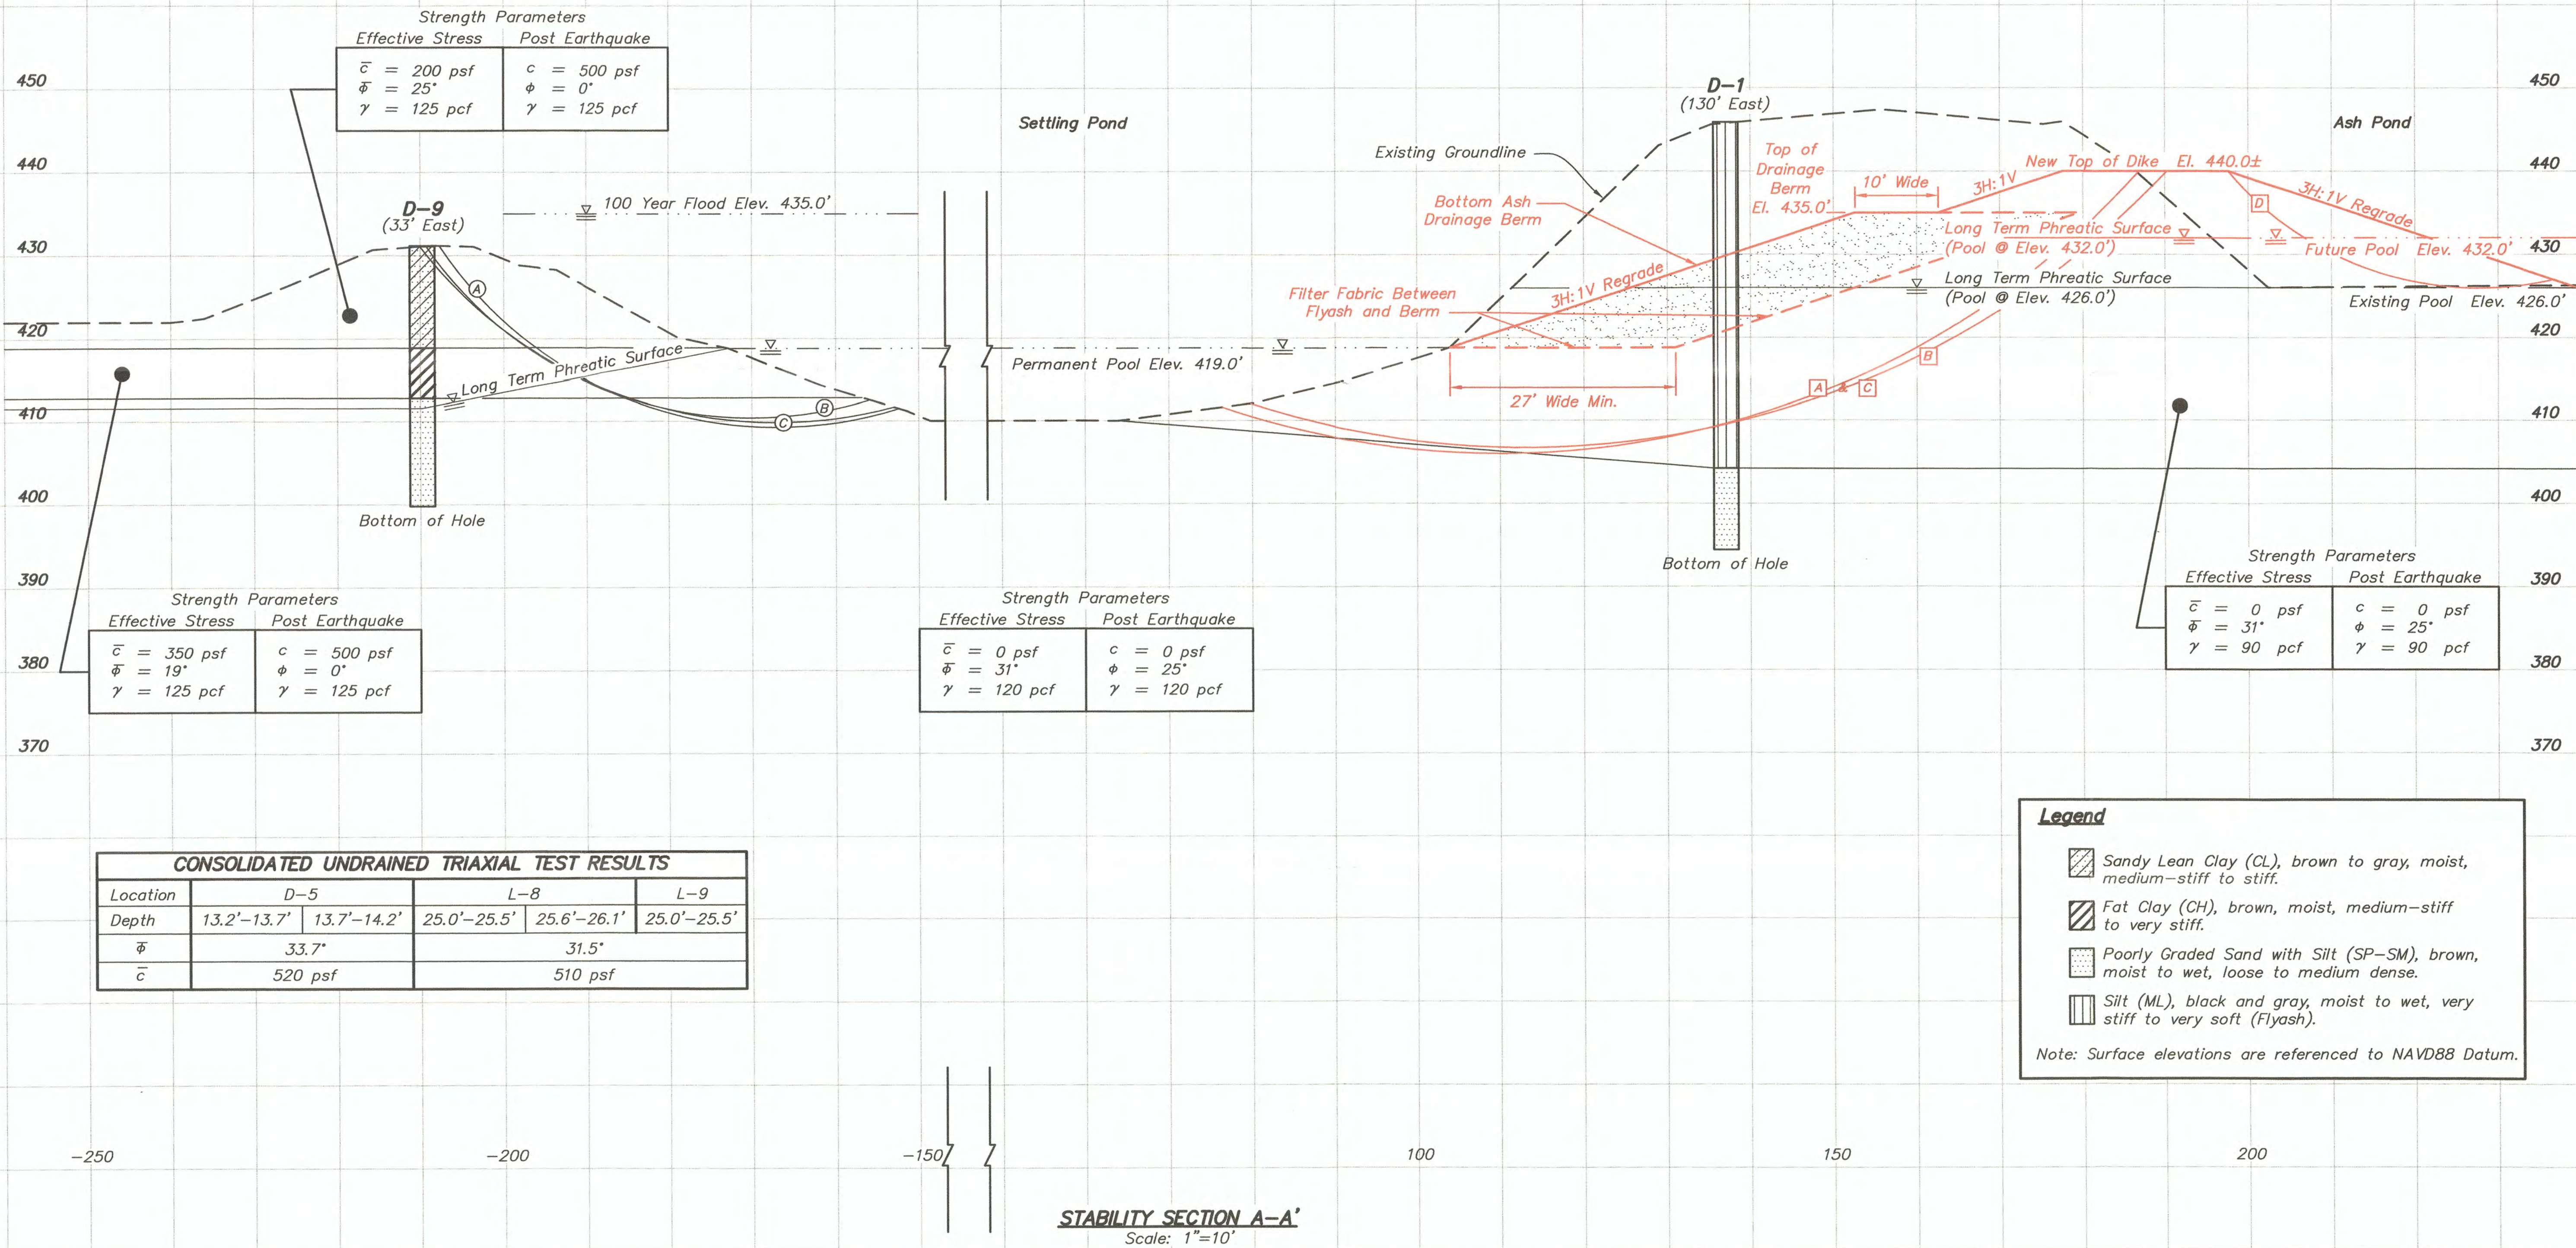
CLAY PERIMETER DIKE FACTORS OF SAFETY		
A	Long Term (Inner Face)	1.8
B	Rapid Drawdown (Inner Face)	1.3
C	Post Earthquake (Inner Face)	1.5

ASH DIKE 3H:1V REGRADE WITH DRAINAGE BERM - FACTORS OF SAFETY		
A	Long Term (Outer Face 3H:1V Regrade with Drainage Berm @ El. 435')	1.5
B	Rapid Drawdown (Outer Face 3H:1V Regrade with Drainage Berm @ El. 435')	1.4
C	Post Earthquake (Outer Face 3H:1V Regrade with Drainage Berm @ El. 435')	1.1
D	Long Term (Inner Face 3H:1V Regrade)	1.5

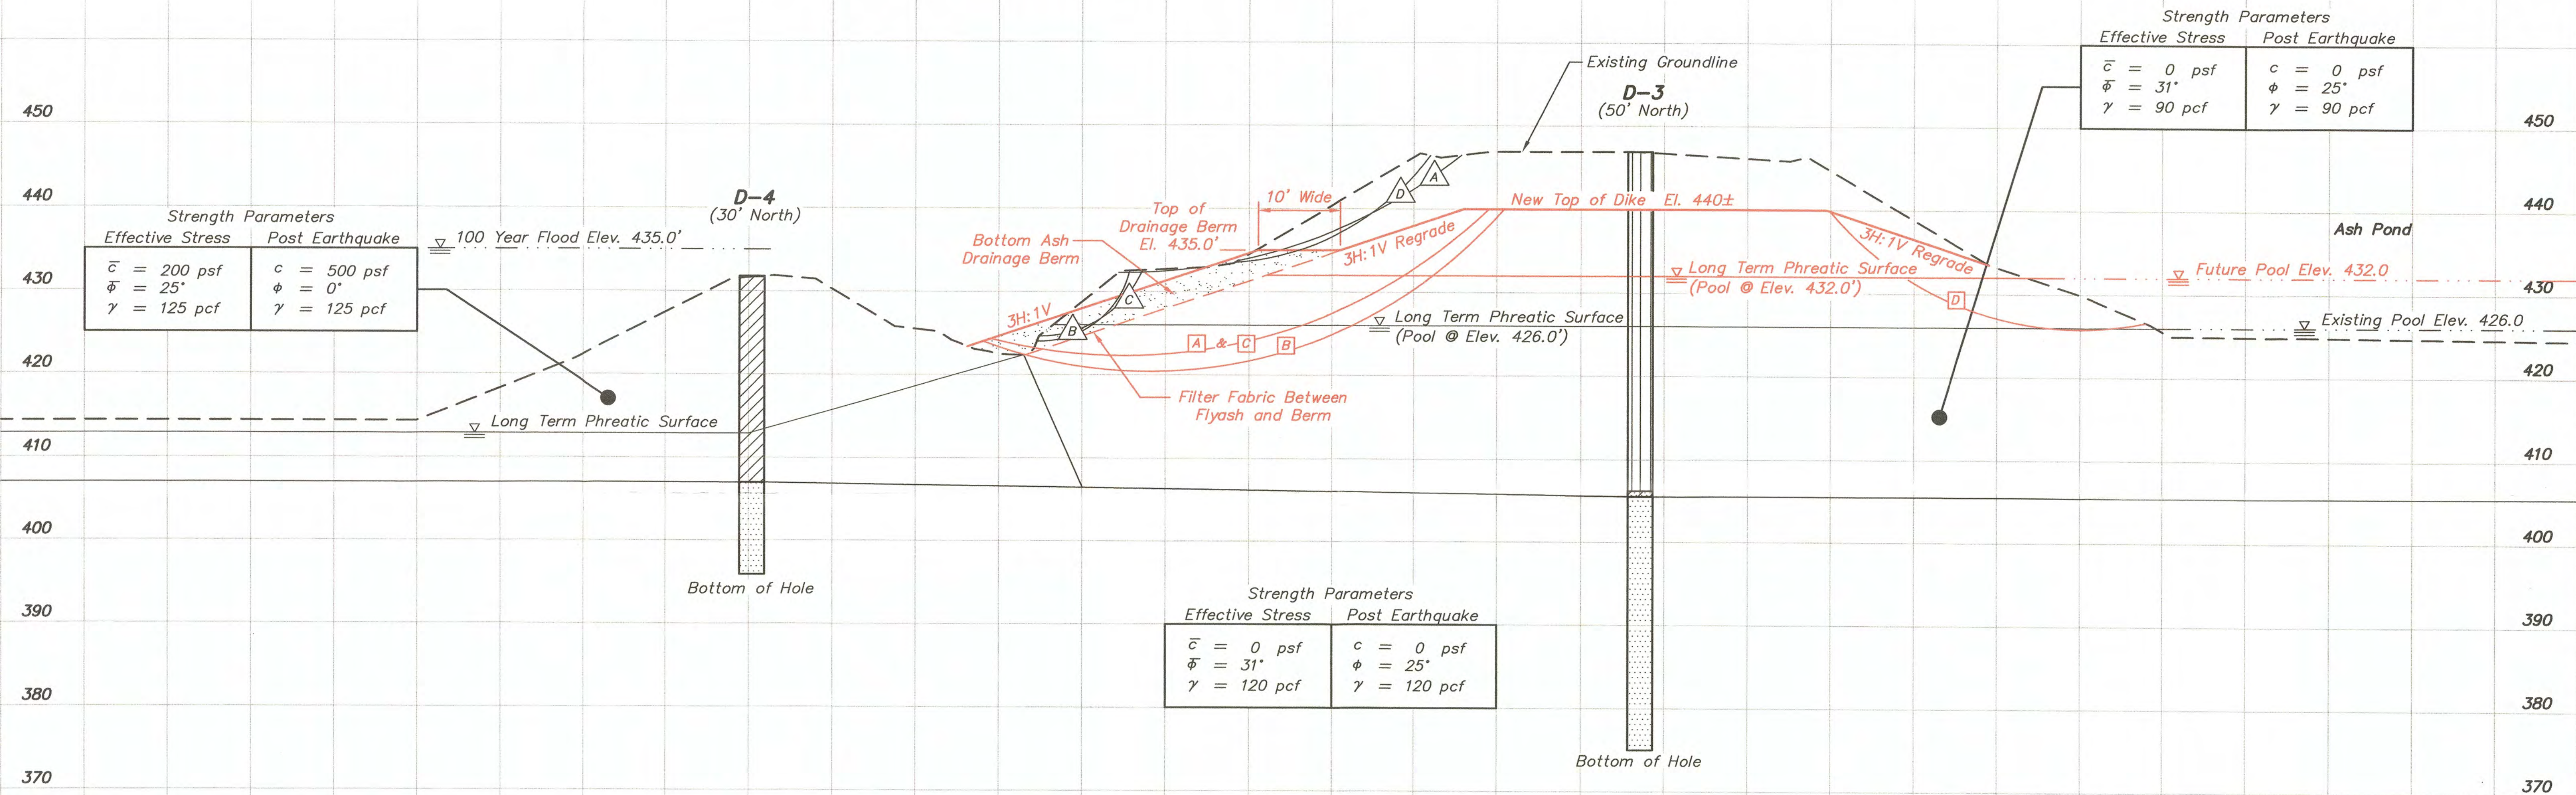
ASH DIKE 3H:1V REGRADE WITH DRAINAGE BERM - FACTORS OF SAFETY		
[A]	Long Term (Outer Face 3H:1V Regrade with Drainage Berm @ El. 435')	1.6
[B]	Rapid Drawdown (Outer Face 3H:1V Regrade with Drainage Berm @ El. 435')	1.4
[C]	Post Earthquake (Outer Face 3H:1V Regrade with Drainage Berm @ El. 435')	1.3
[D]	Long Term (Inner Face 3H:1V Regrade)	1.5

EXISTING ASH DIKE FACTORS OF SAFETY		
[A]	Long Term (Outer Face with Pool @ El. 426')	1.3
[B]	Long Term (Outer Face with Pool @ El. 426')	1.0
[C]	Rapid Drawdown (Outer Face)	0.2
[D]	Post Earthquake (Outer Face with Pool @ El. 426')	0.9

CONSOLIDATED UNDRAINED TRIAXIAL TEST RESULTS		
Location	D-5	
Depth	13.2'-13.7'	13.7'-14.2'
$\bar{\phi}$	33.7°	
$\bar{c}$	520 psf
